**GAF Corporation**

HAZARDOUS AIR POLLUTANT SOURCE INSPECTION FORM

Company name: G A F Corporation Date: October 30, 1974

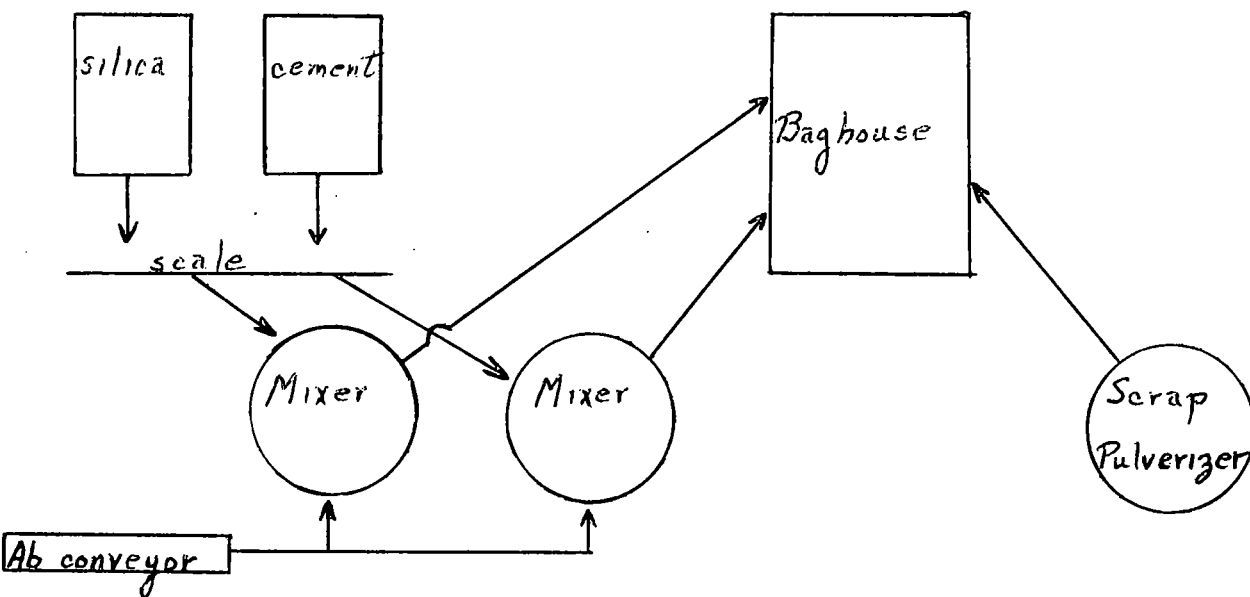
Flow diagram of operation and baghouse:

This baghouse serves 2 mixers and a scrp pulverizer. Bags are cotton sateen.
